CORRECTIVE ACTION PROGRAM FOR BROMOCHLOROMETHANE-CONTAINING "FIRE-SAFE" DIESEL FUEL

FINAL REPORT
AFLRL No. 81

U. S. Army Fuels and Lubricants Research Laboratory
Southwest Research Institute
San Antonio, Texas

September 1976

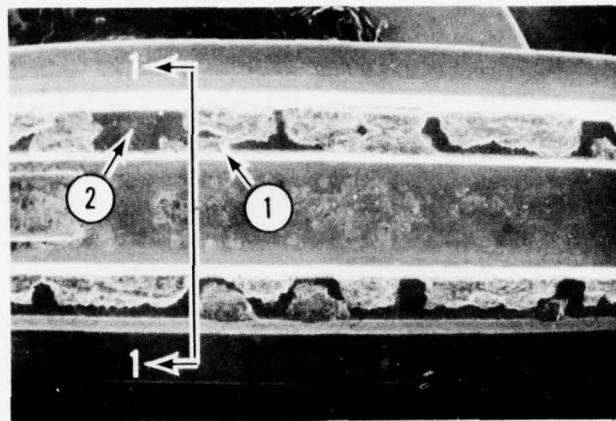
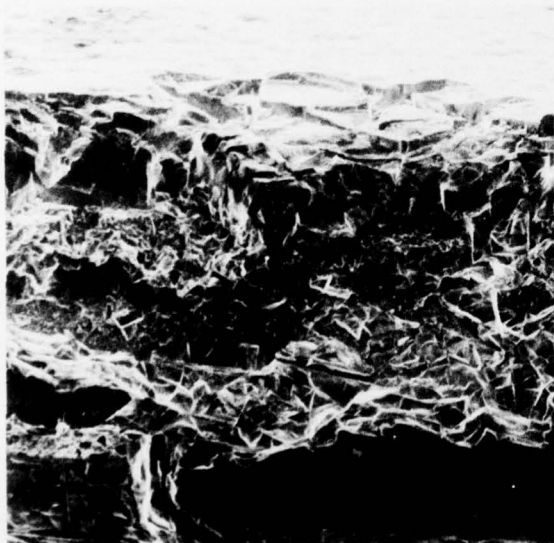
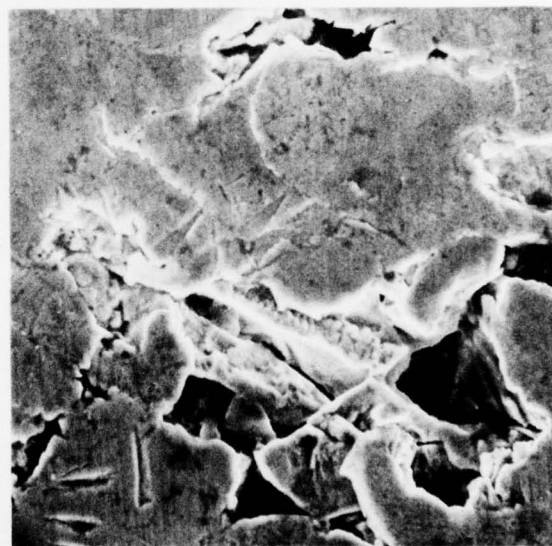
FIGURE 1. SEM MICROGRAPHS OF WEAR SURFACE OF FAILED
PISTON RING FROM TCM AVDS 1790-2C ENGINE
ENDURANCE TEST WITH BCM FSF

A scuffing mechanism was suggested by the ring manufacturer² for the oil-control piston ring failure, but this does not appear to be the same mechanism for the ring examined by AFLRL. The following evidence developed by AFLRL indicates a corrosive mechanism for the piston ring failure.

- a. No scuffing was evident on the chromium plating not yet chipped off of the piston ring (Figures 1 and 2)*.

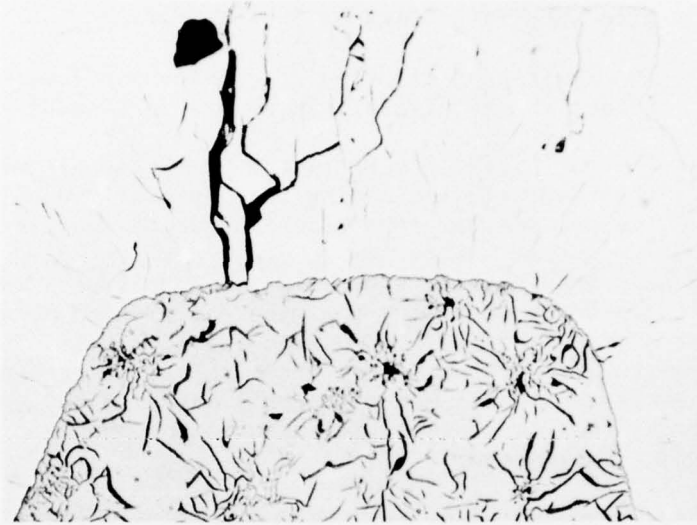
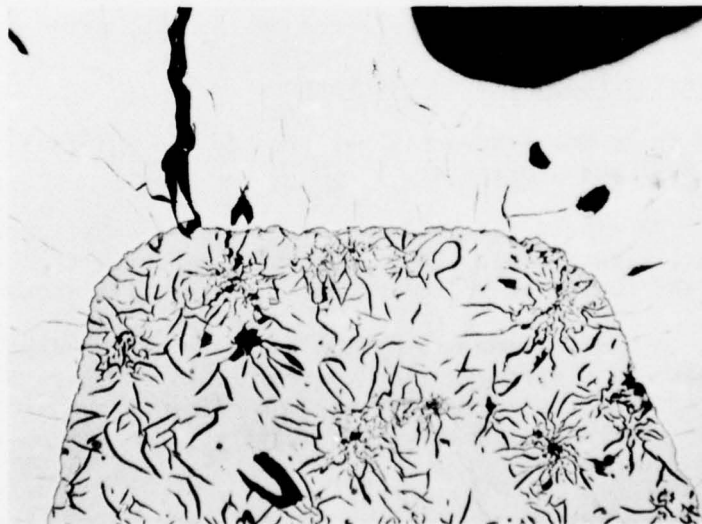
FIGURE 3. MICROGRAPHS OF SECTION THROUGH FAILED PISTON RING
Section 1-1, Figure 1(a). Unetched.

- b. There was evidence of corrosion debris in some of the intergranular cracks in both the chromium plating and in the cast iron substrate (Figures 3, 4, and 5).
- c. No significant dilution of crankcase oil with raw fuel was evident by AFLRL analysis of used oil samples (Table 1).
- d. The ratio of Cl to Br in the crankcase oil was less than in the raw fuel, indicating that much of the halogen content of the oil stemmed from blowby products--not raw fuel (Table 1).

- a. The failure of the piston ring was associated with no inherent plating defects.
- b. Failure of the piston ring provided to AFLRL occurred by intergranular cracking of the chromium plating and subsequent loss of chips of the plating. The metallographic features of the cracking are compatible with failure due to inadequate lubrication, but the possibility of stress-corrosion cracking due to a contaminant cannot be discounted.

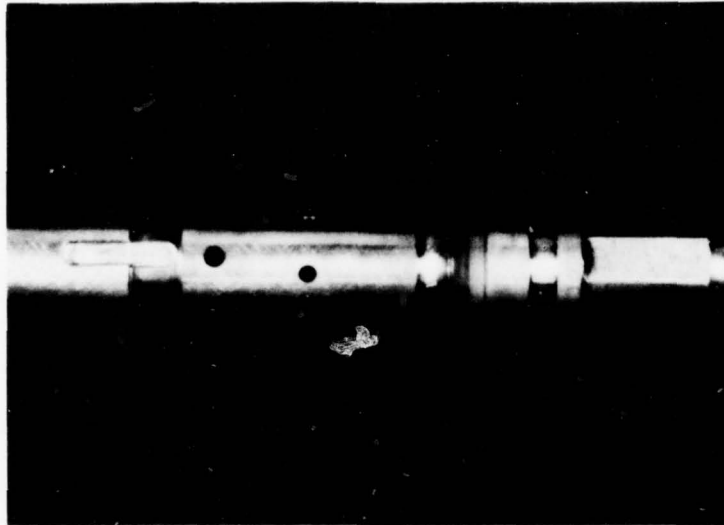
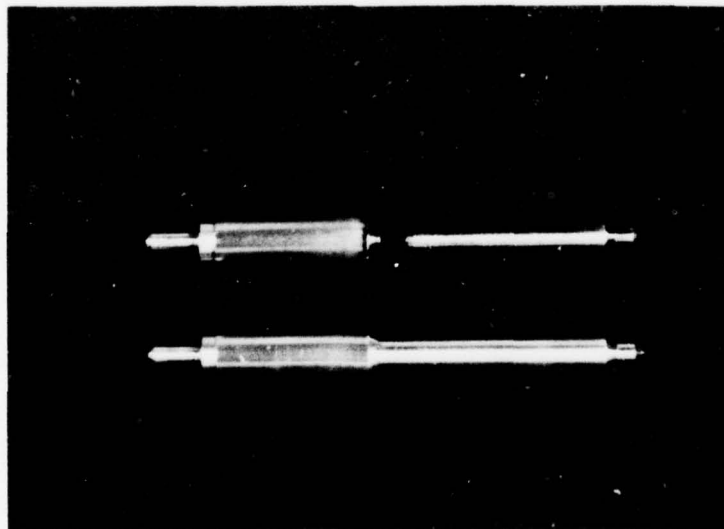
The surface topography of these parts was also examined in the scanning electron microscope (SEM). In the case of the pintle [Figure 6(b)], no evidence of attack of the surface was apparent in the dark zone and the microscopic features indicated the presence of a loose deposit, Figure 7(a). Distinctly different topographic features were noted between the dark zone and clean surface on the plunger as shown in Figures 7(b) and 7(c). Within the dark zone the surface was rough and pitted, suggestive of corrosive attack.

The dark area on the pintle was found to be acetone soluble, and SwRI metallurgists saw no evidence of corrosion [Figure 6(b)]. As in the case of the previously discussed engine parts, significant quantities of chlorine were present in dark zone on the pintle (see Table 4).

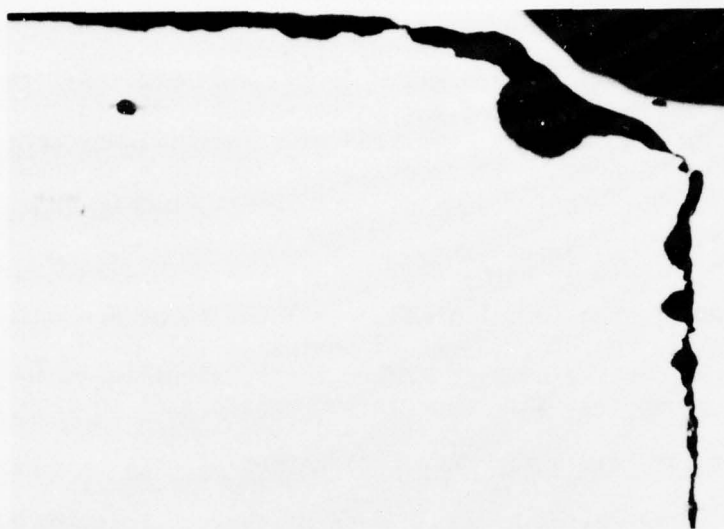
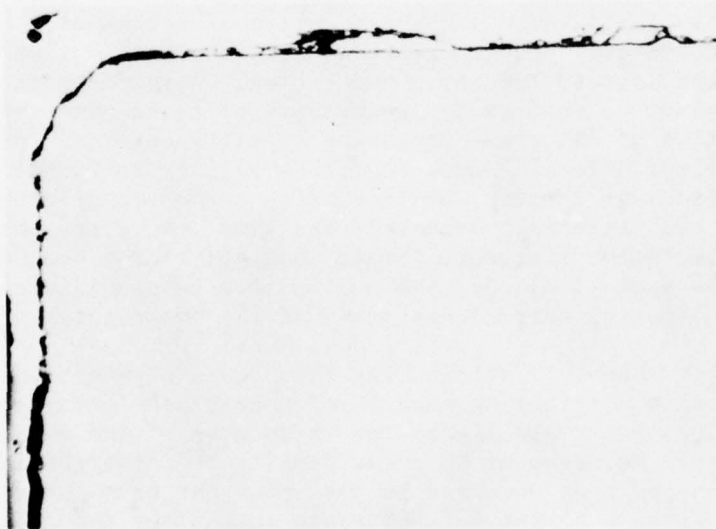
FIGURE 8. MICROGRAPH OF SECTION THROUGH INJECTOR
PLUNGER. Unetched.

A longitudinal metallographic section was taken through the dark zone of the plunger. Examination of this section revealed definite pitting of the surface within the dark zone, while the surface profile at the clean zone was extremely flat and smooth (see Figure 8). These metallographic features together with the fine-scale topography observed in the SEM examination are definite evidence that the dark band on the plunger is the result of corrosive attack. It should be noted that both sulfur and chlorine were present in significant amounts within this zone of the plunger. Either of these elements could cause corrosive attack of the plunger."

- e. The dark band on the injector pump plunger definitely resulted from corrosive attack.

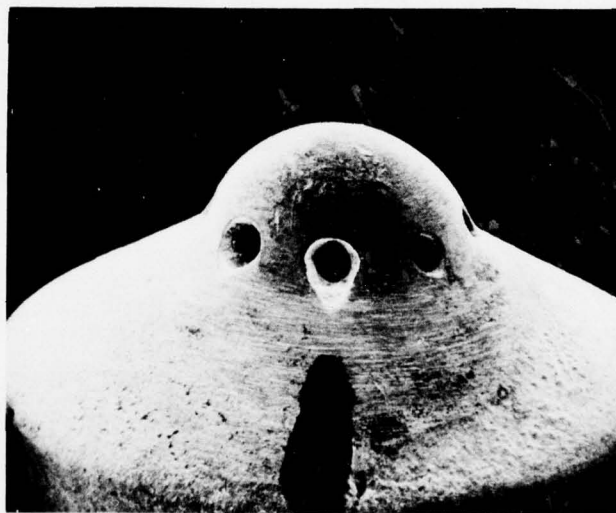
FIGURE 9. FAILED INJECTOR TIP (CENTER HOLE IN
MICROGRAPH DESIGNATED AS NO. 1)
FROM AVDS 1790-2C ENGINE EN-
DURANCE TEST WITH BCM FSF

- d. The mechanism of enlargement of the injector tip holes was not definitely identified, but it is most likely that the metal loss occurred as the result of corrosion rather than by erosion, possibly during engine shut-down periods.

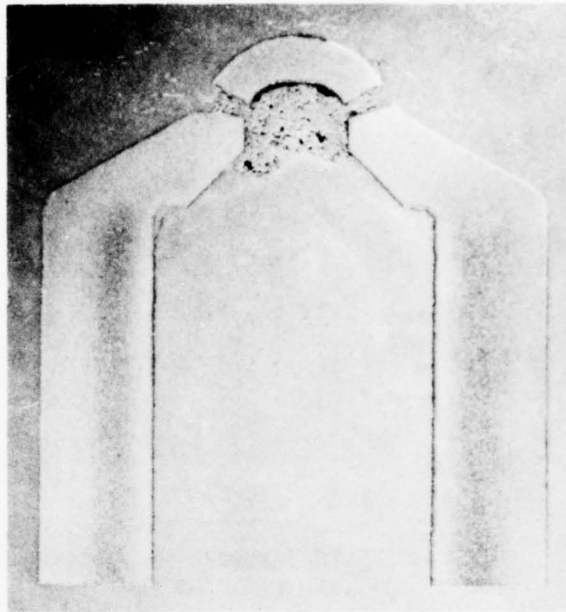
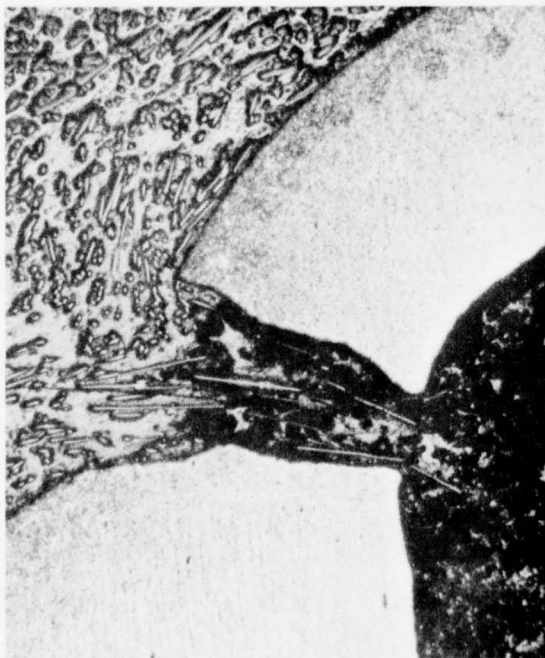
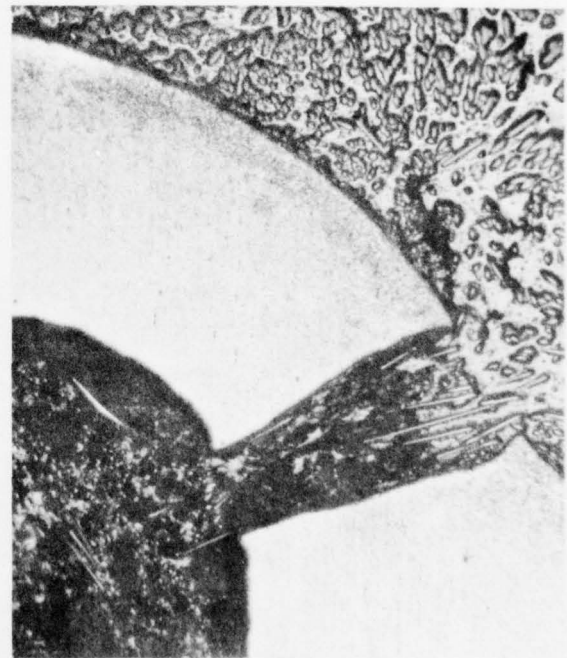
FIGURE 11. SECTIONED SPECIMEN REVEALING CROSS-SECTIONS OF LARGEST AND SMALLEST HOLE IN FAILED AVDS 1790-2C INJECTOR NOZZLE

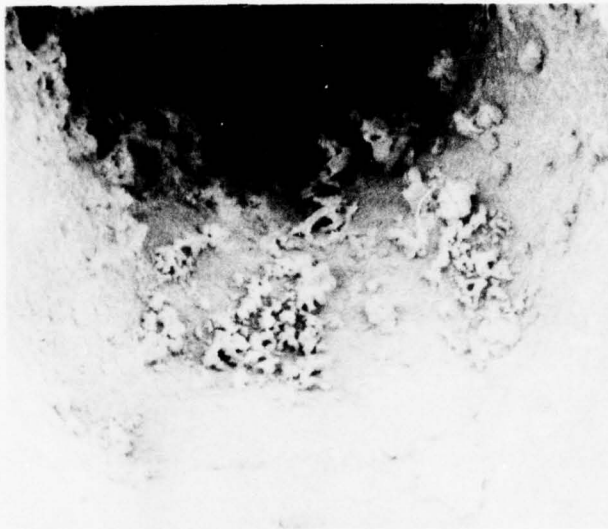
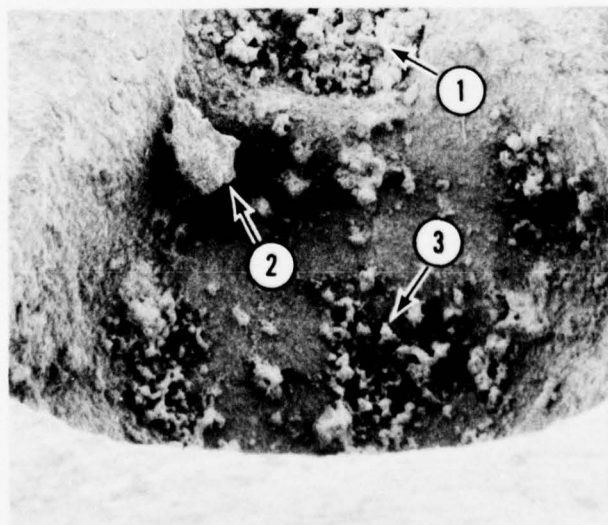
FIGURE 12. AREAS OF SEM MICROPROBE EXAMINATION
FAILED INJECTOR TIP. Hole No. 1.

Location ^a	Peak/Background ^b	
	Cl	Br
Area 1	469/52	Not detected
Area 2	283/48	Not detected
Area 3	42/10	Not detected
Conical Surface	500/85	1350/1200
Notes:		
^a See Figure 12 for location of areas examined.		
^b Counts in 30 sec., $i = 0.2 \times 10^{-7}$ amps.

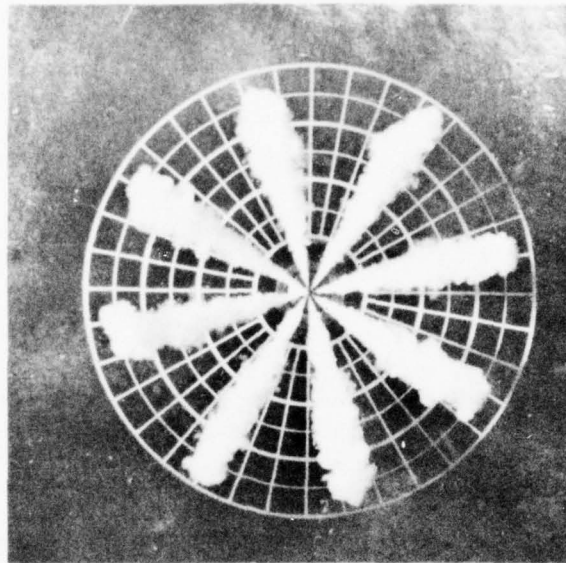
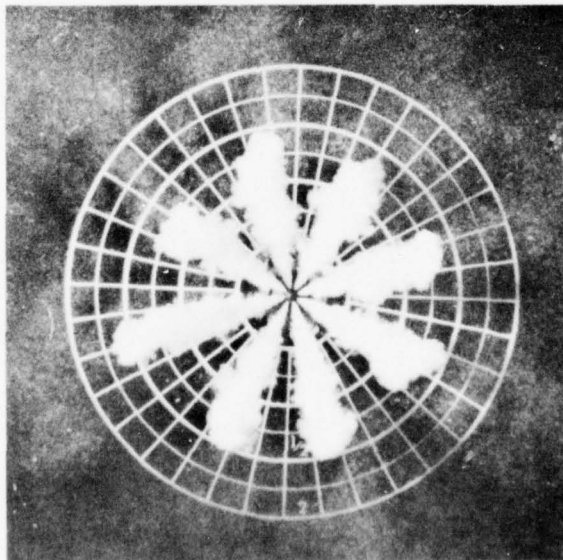
FIGURE 13. NEAT DIESEL FUEL SPRAY PATTERNS FOR NOZZLES
FROM AVDS 1790-2C ENGINE

Rather than only attributing the previously-mentioned excessive smoke emissions to overfueling because of nozzle hole enlargement, an alternate explanation could lie in the influences of the nonuniform nozzle injector tip hole enlargement on spray density and distribution. Figure 13 illustrates changes that occurred in the spray patterns* of a typical nozzle from the AVDS 1790-2C engine FSF endurance test after about 30 hours exposure to BCM FSF (with overnight shutdowns). These reveal substantial decreases in spray penetration with attendant increases in spray-droplet

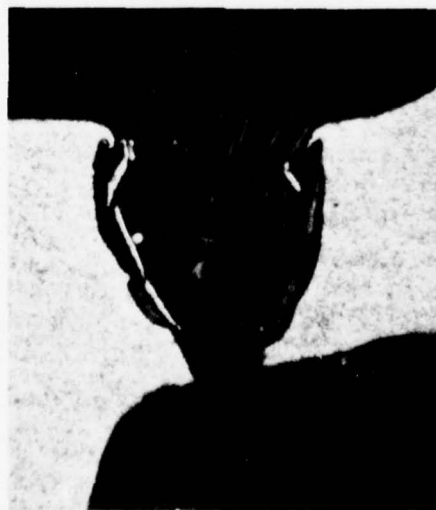
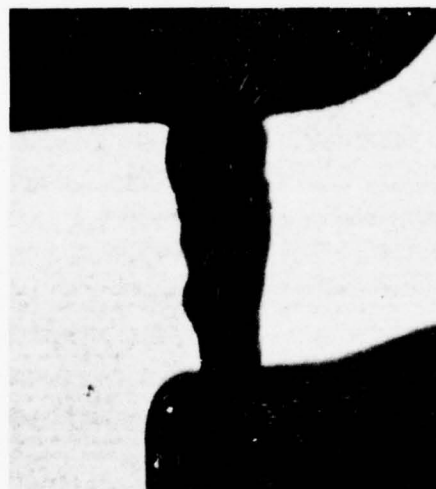
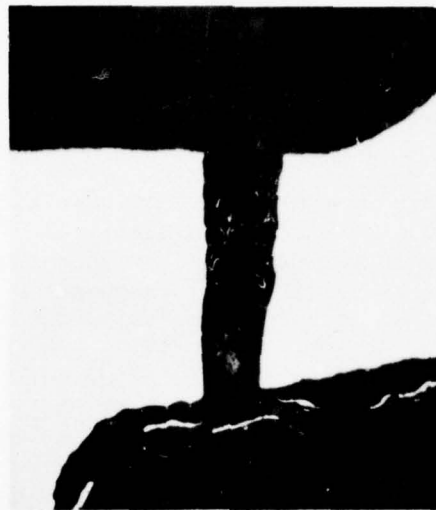
After the test, the engine was disassembled and inspected, with the following effects noted: (1) substantial reduction in injector tip hole enlargement, (2) increased cylinder liner wear, (3) increased piston ring end-gap change (approximately 0.030 inch), and (4) extreme blackening of all engine parts below the ring belt. The black color seemed to be caused by a thin layer of lacquer-like carbonaceous substance containing bromine and iron in

FIGURE 16. SECTION THROUGH LARGEST HOLE IN V6-155 ENGINE FUEL INJECTOR NOZZLE AFTER 80 HOURS OPERATION
